QEP Energy Company

Enhanced Reclamation Program

Presented By:
Stephanie Tomkinson
Senior Biologist
July 12, 2010

Utah Energy Forum “Environmental Management in Oil and Gas Operations”

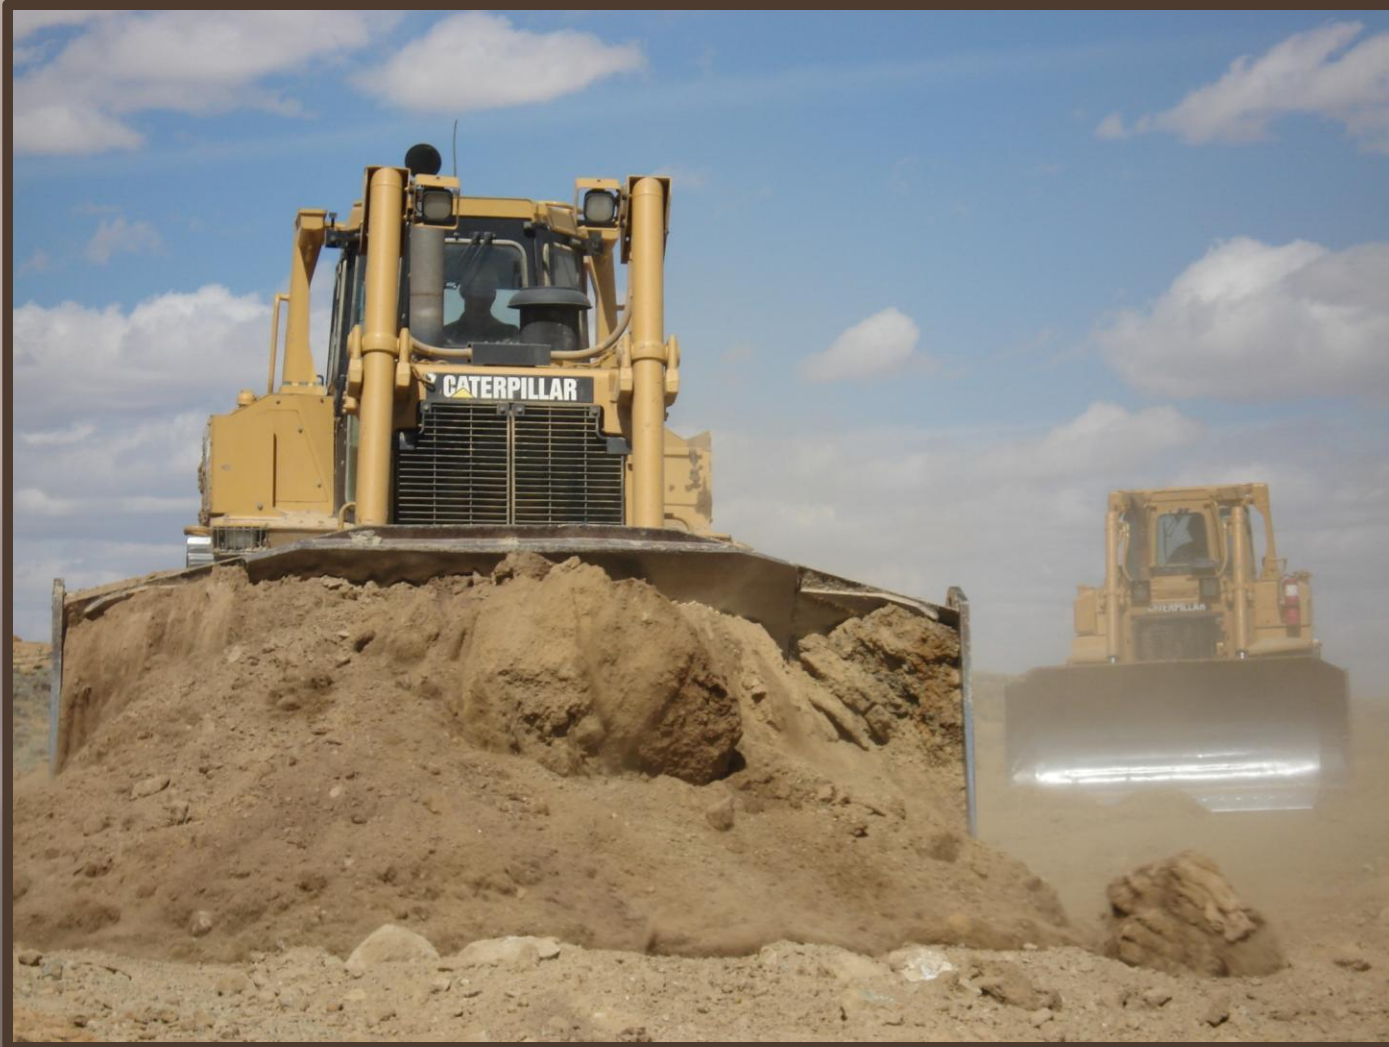
Reclamation Process

- Empty and backfill reserve pit

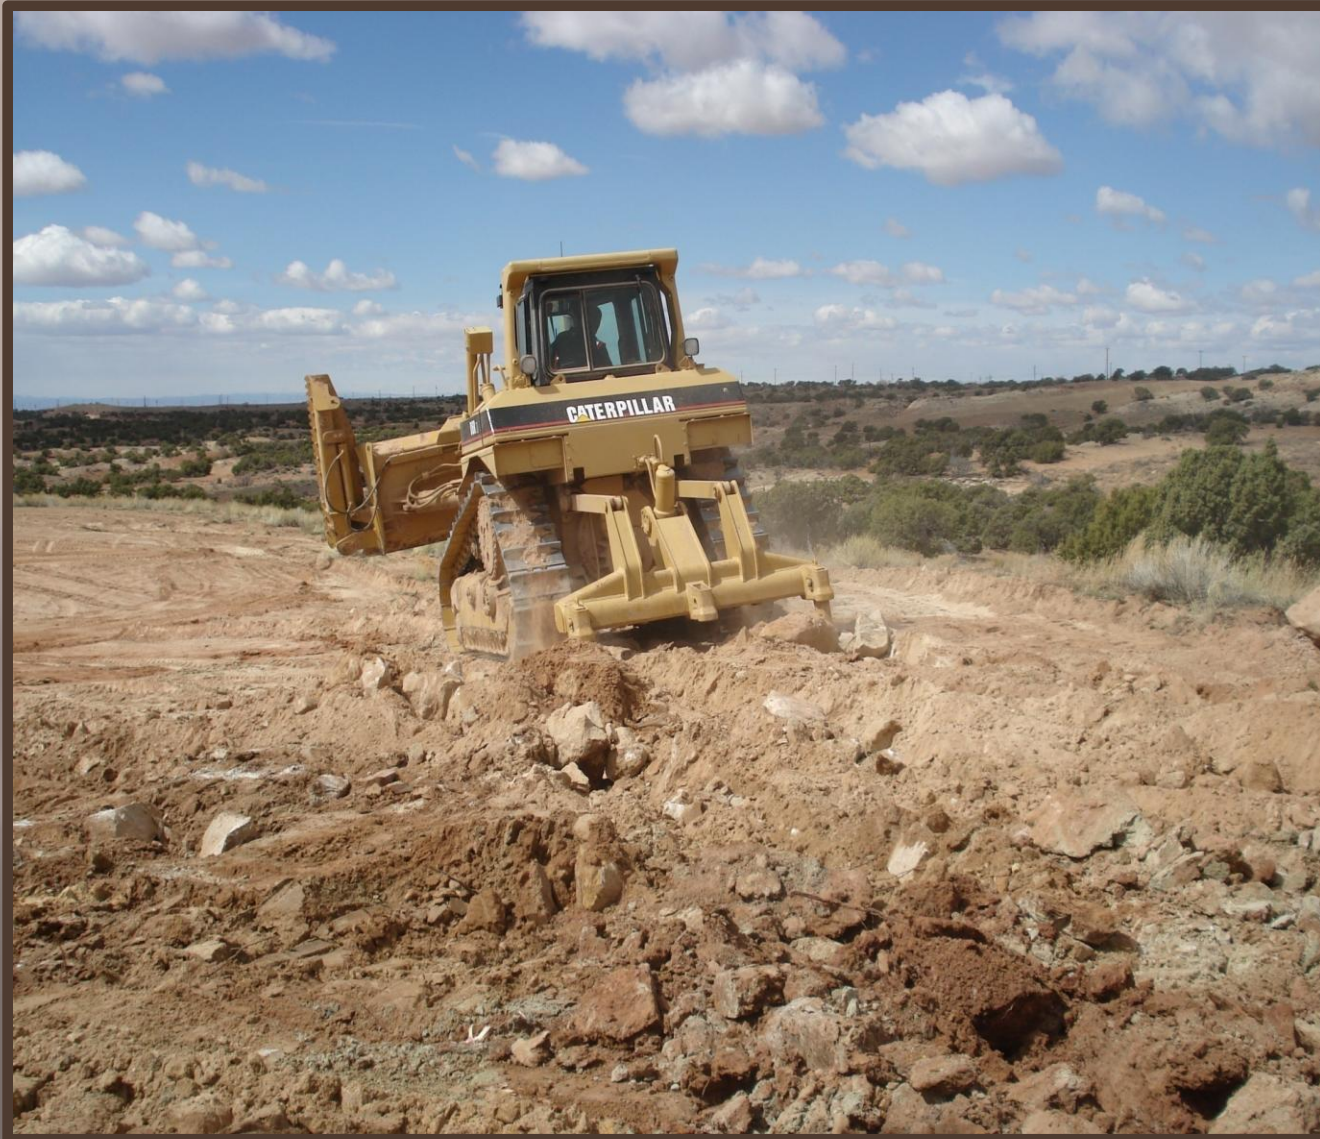
Reclamation Process

- Rip to relieve compaction

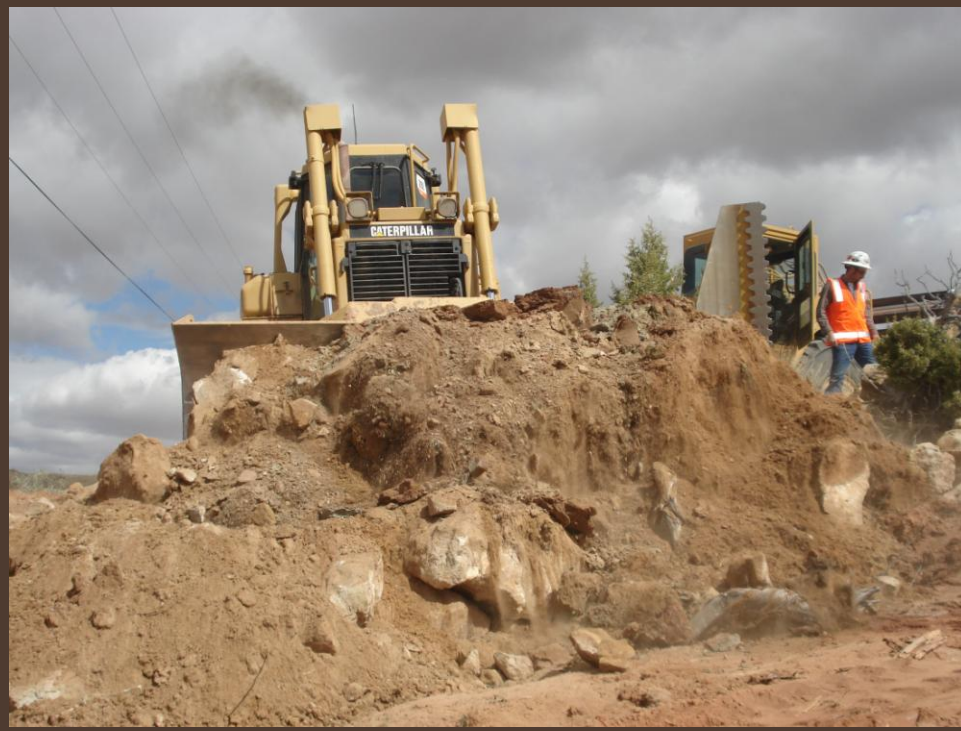
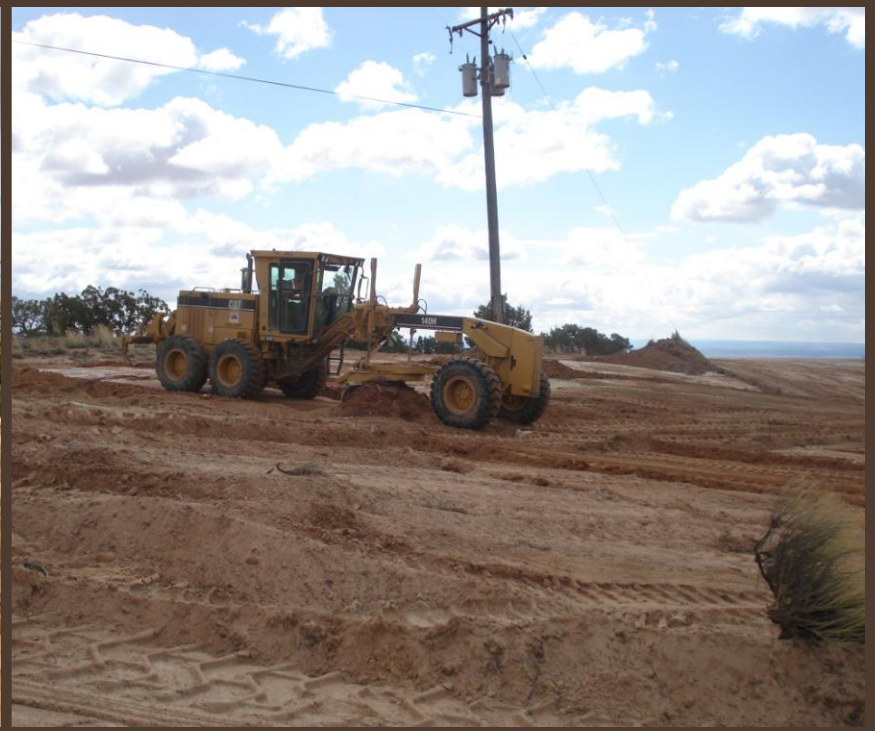
Reclamation Process

- Recontour

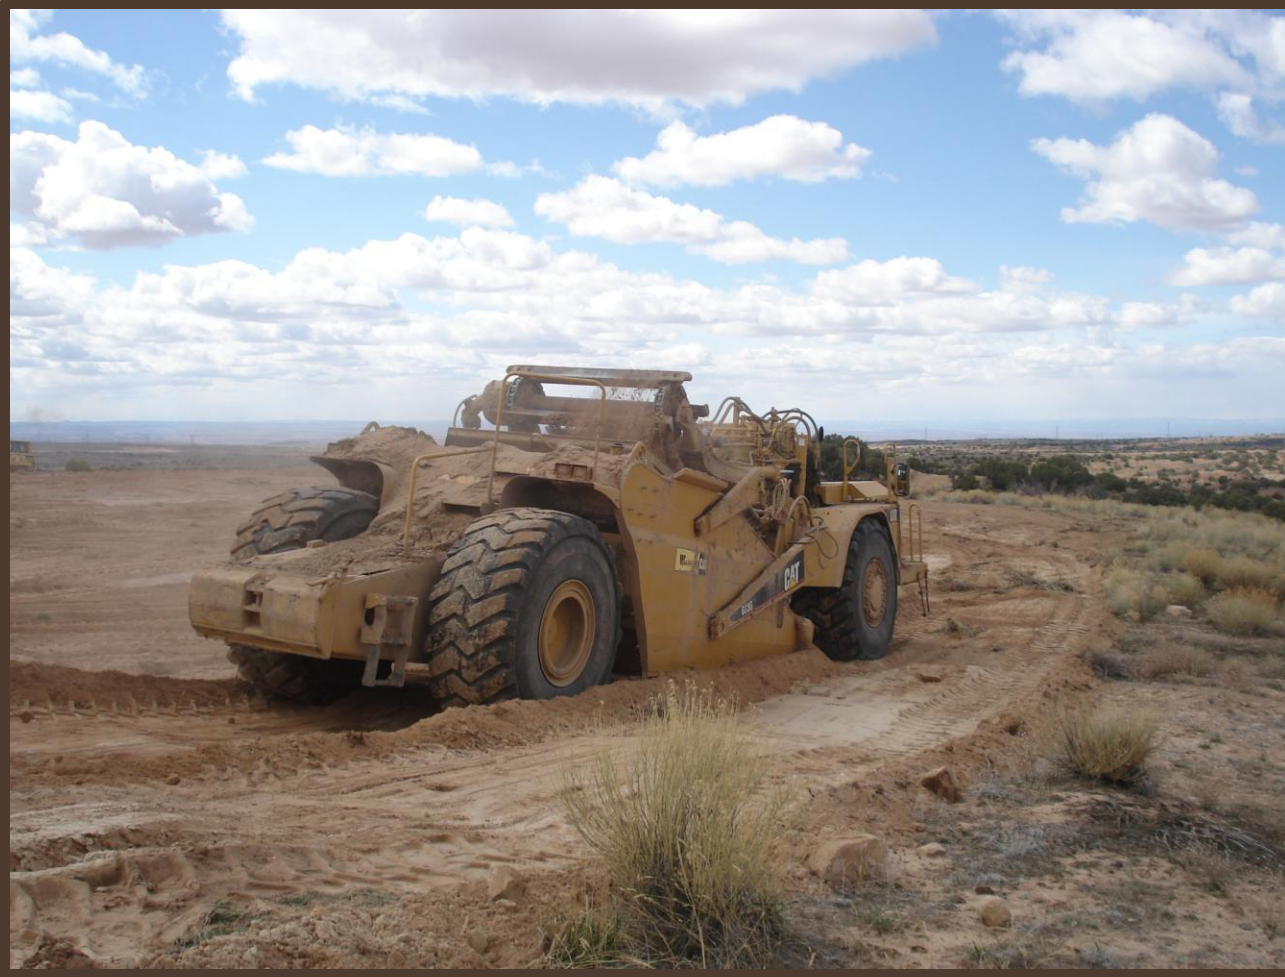
Reclamation Process

- Spread topsoil

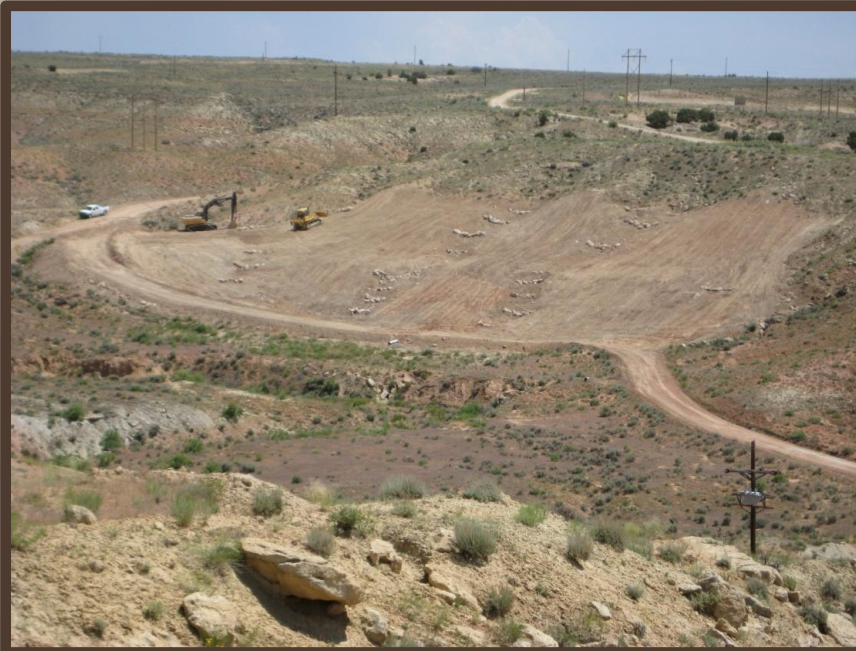
RW 14-20B

Plugged and Abandoned June 2008

Reclaimed Fall 2008

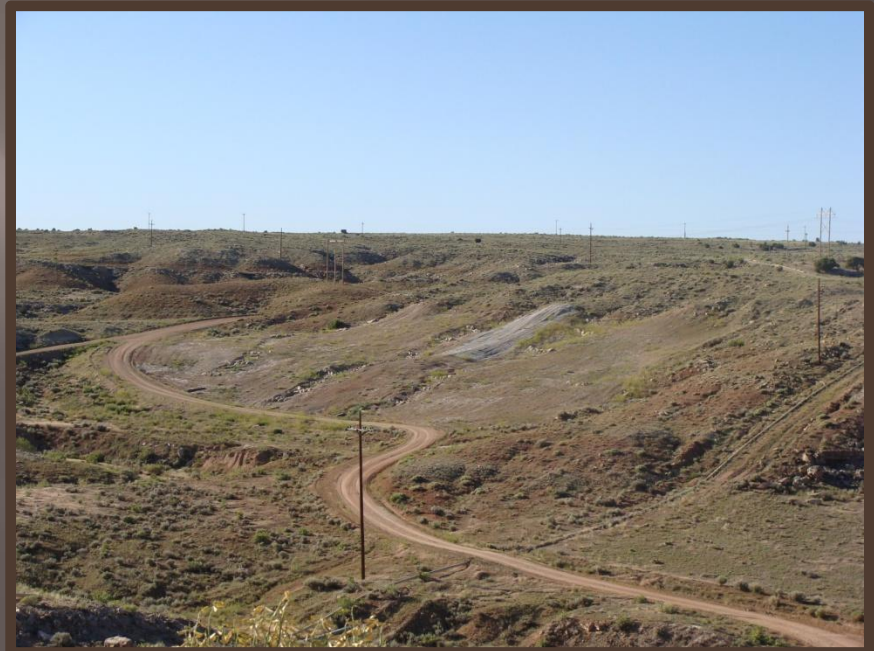
RW 14-20B

July 6, 2010 2nd Growing Season

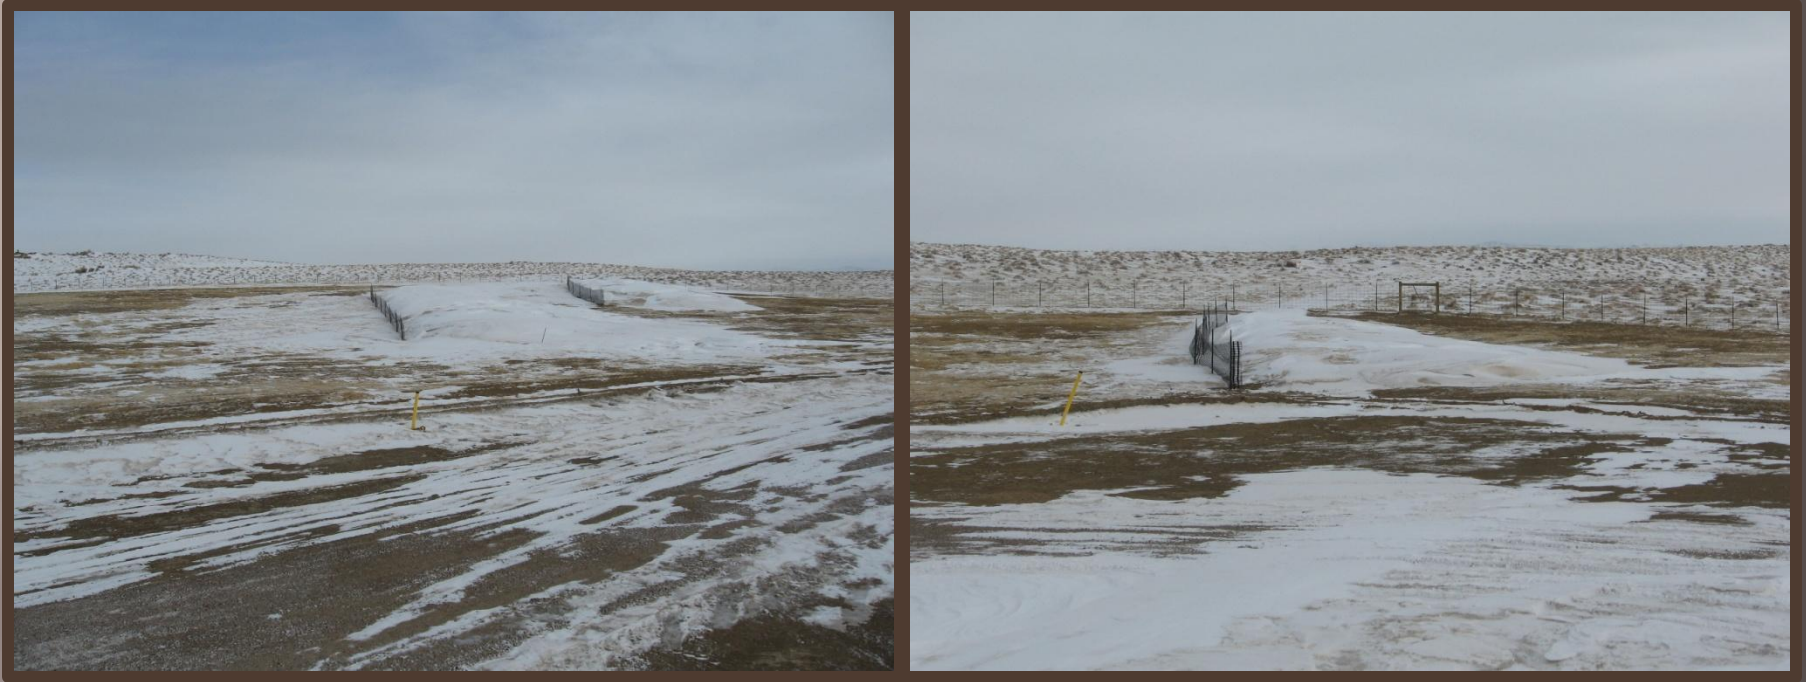
Sparks Ridge 1: February 12, 2008

1st winter after fall planting and installing snow fence

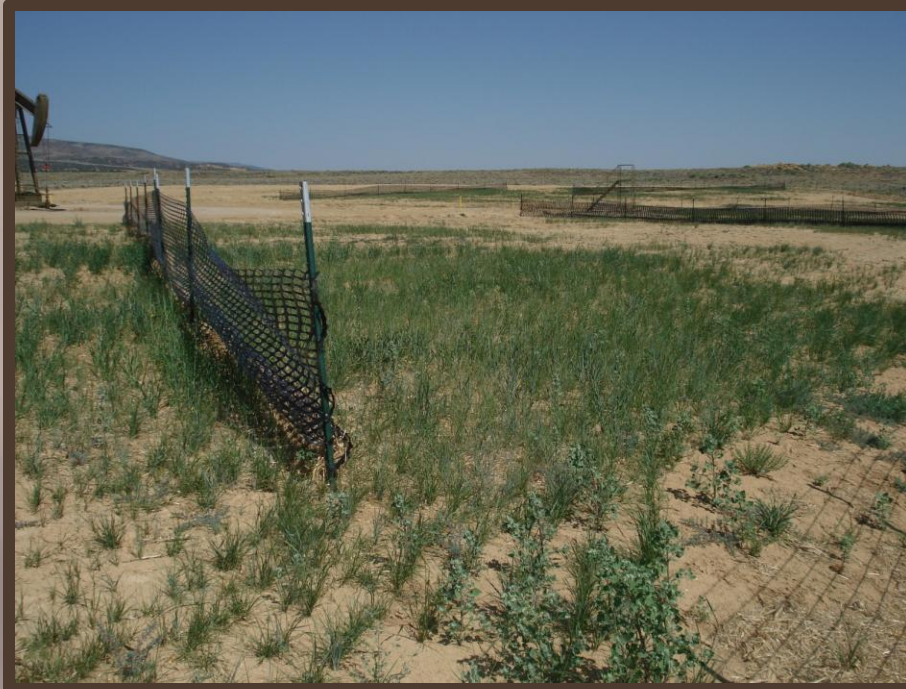
Sparks Ridge 1: July 8, 2008

1st growing season - effects of snow fence

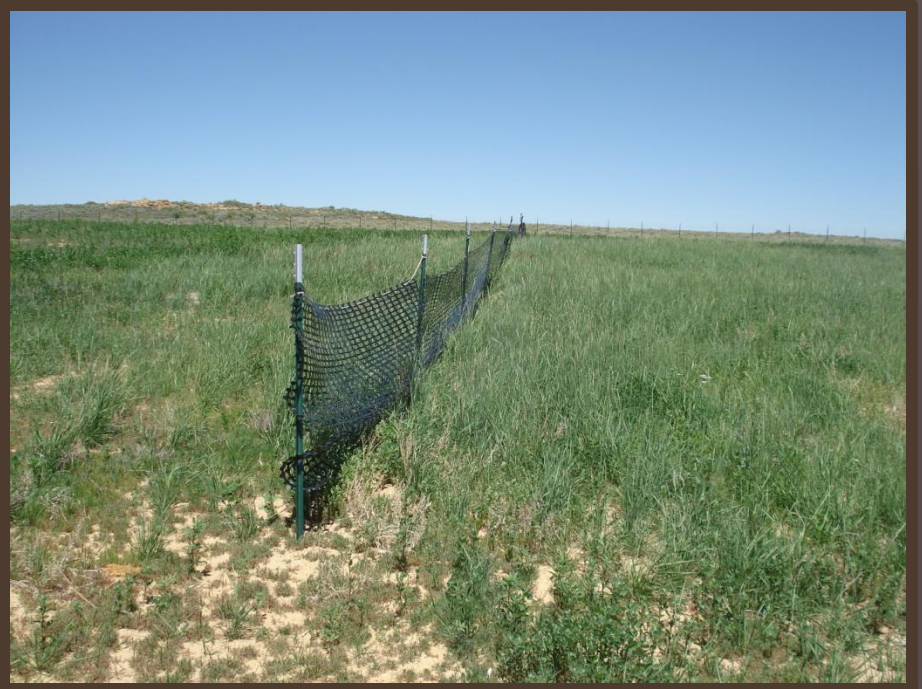
Sparks Ridge 1: June 23, 2009

2nd growing season - effects of snow fence

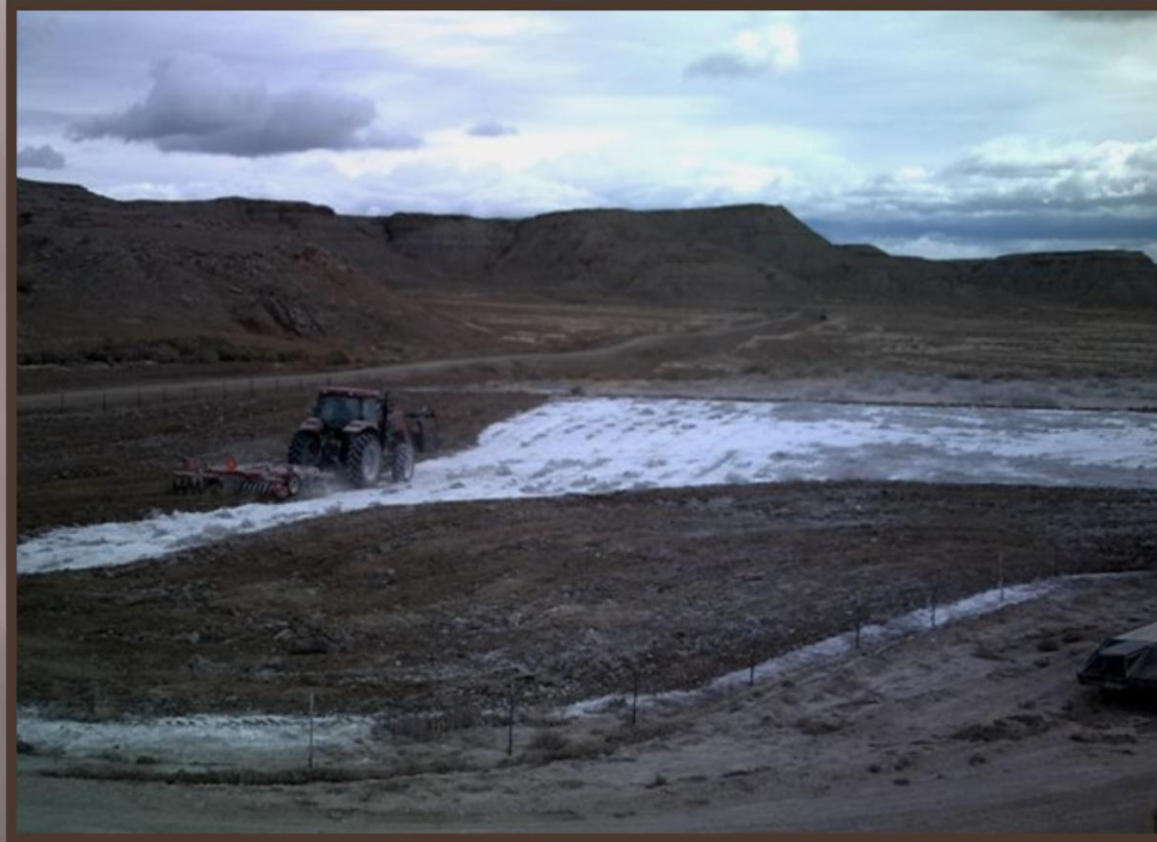
Soil Amendment: Gypsum

Disced into top 3" of soil.

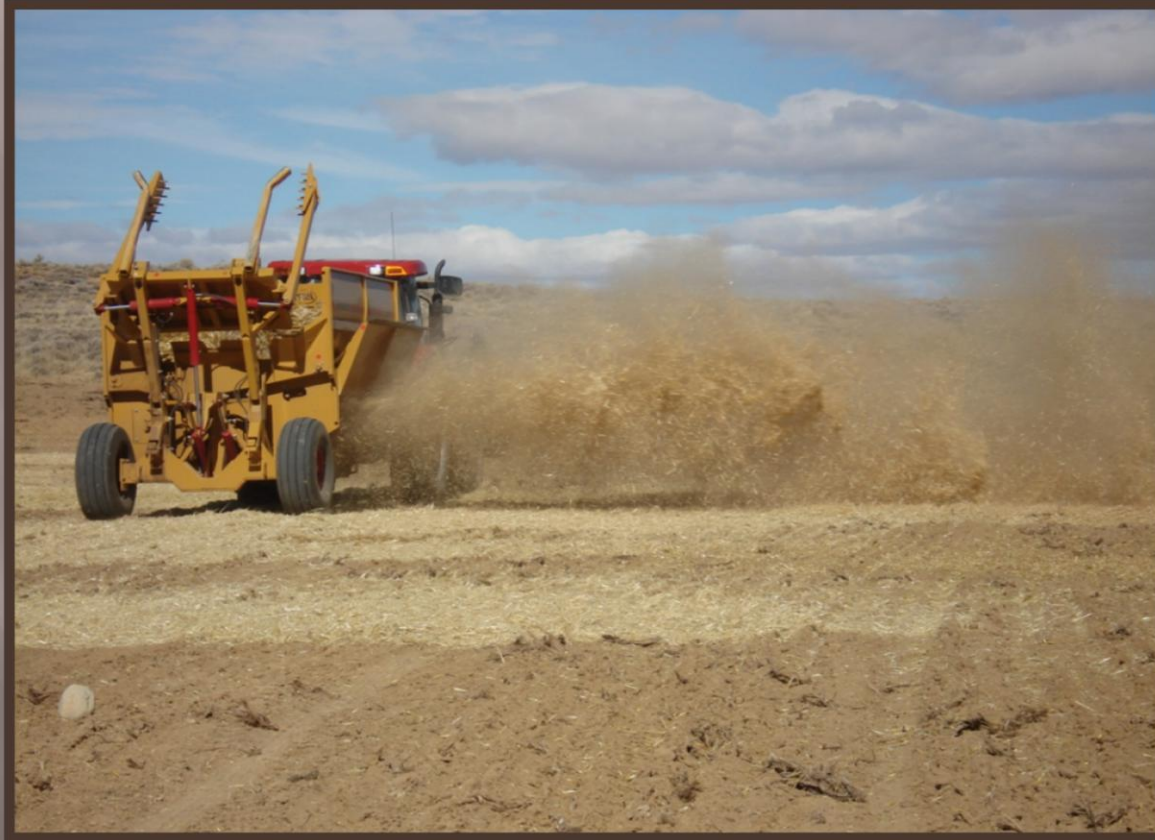
Straw Mulch

Straw mulch being applied with hay-buster.

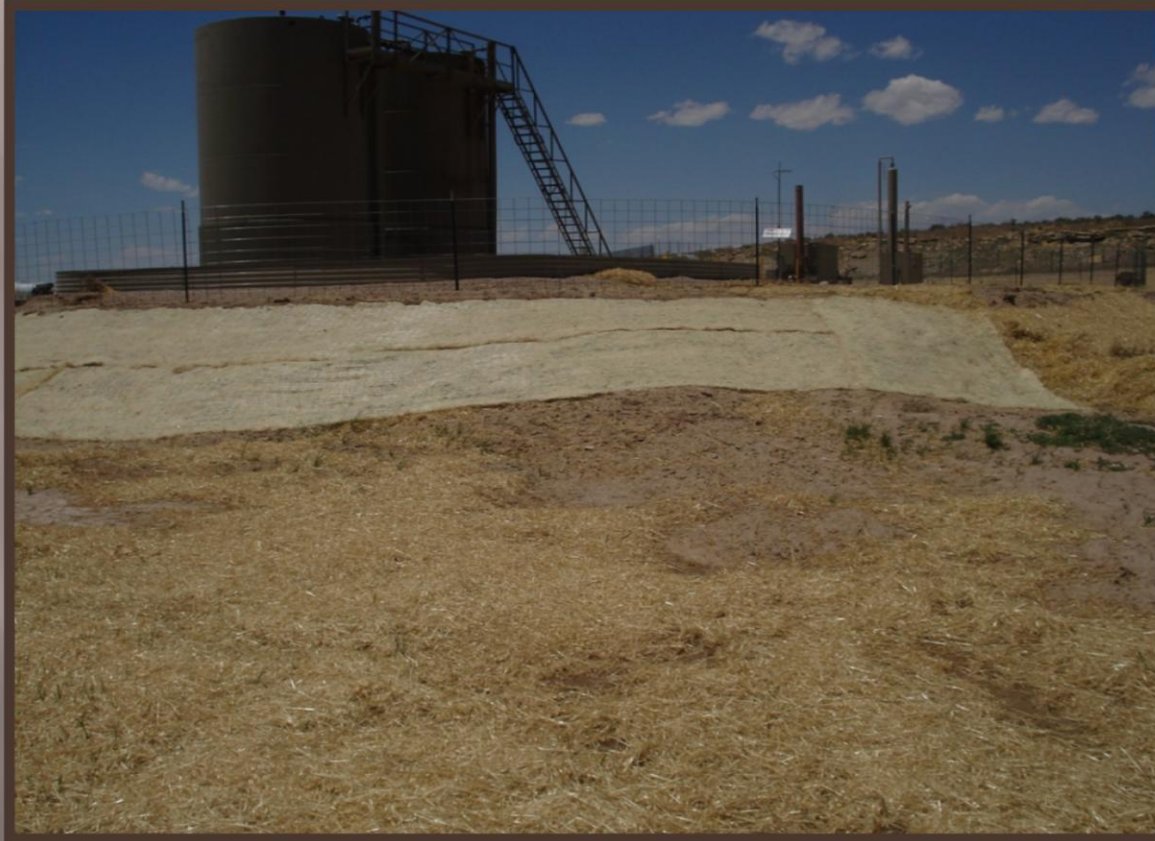
Matting on steep slopes to help control erosion.

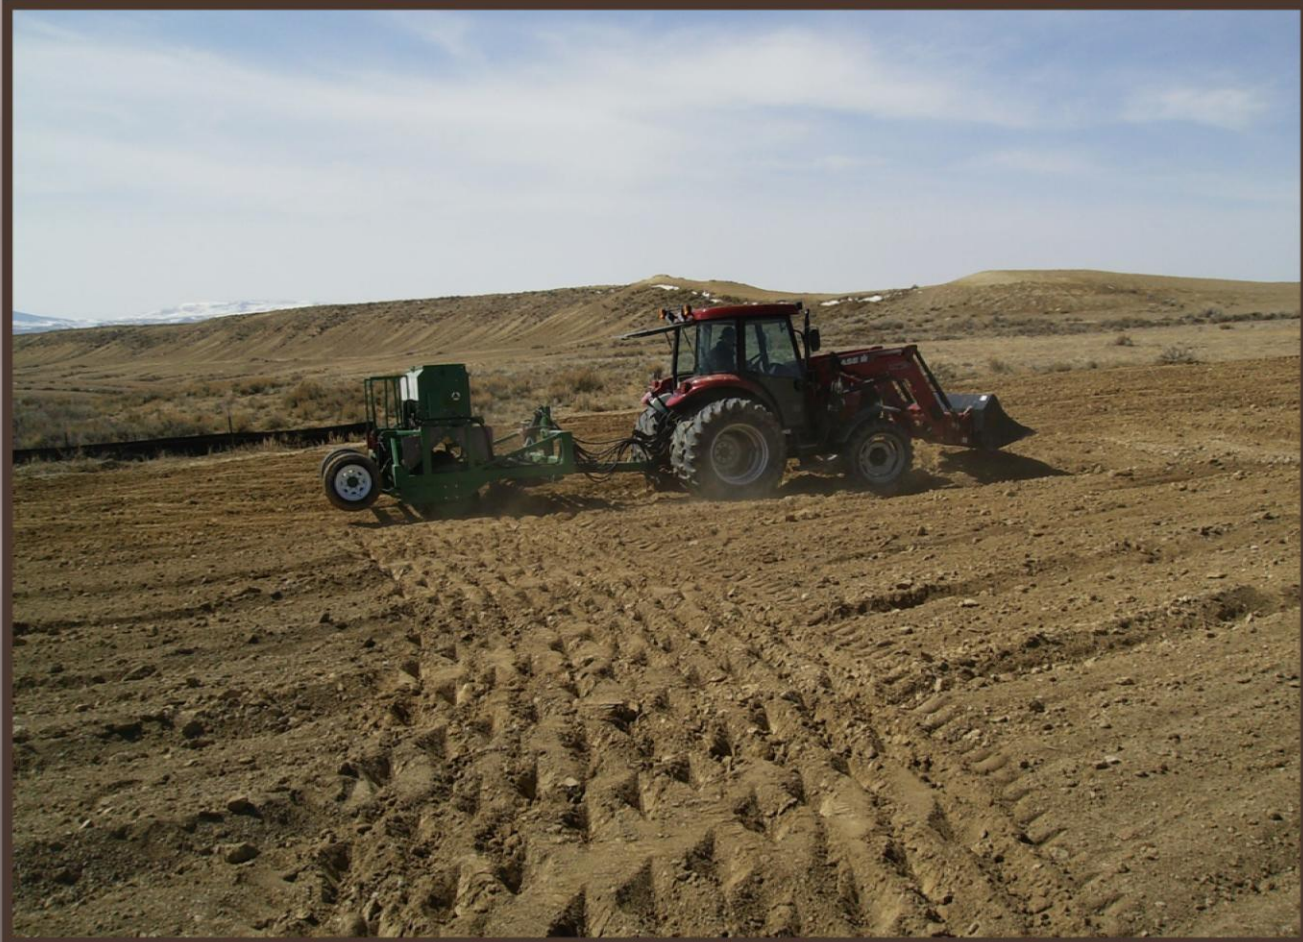
Imprinting

Moisture retention and erosion control.

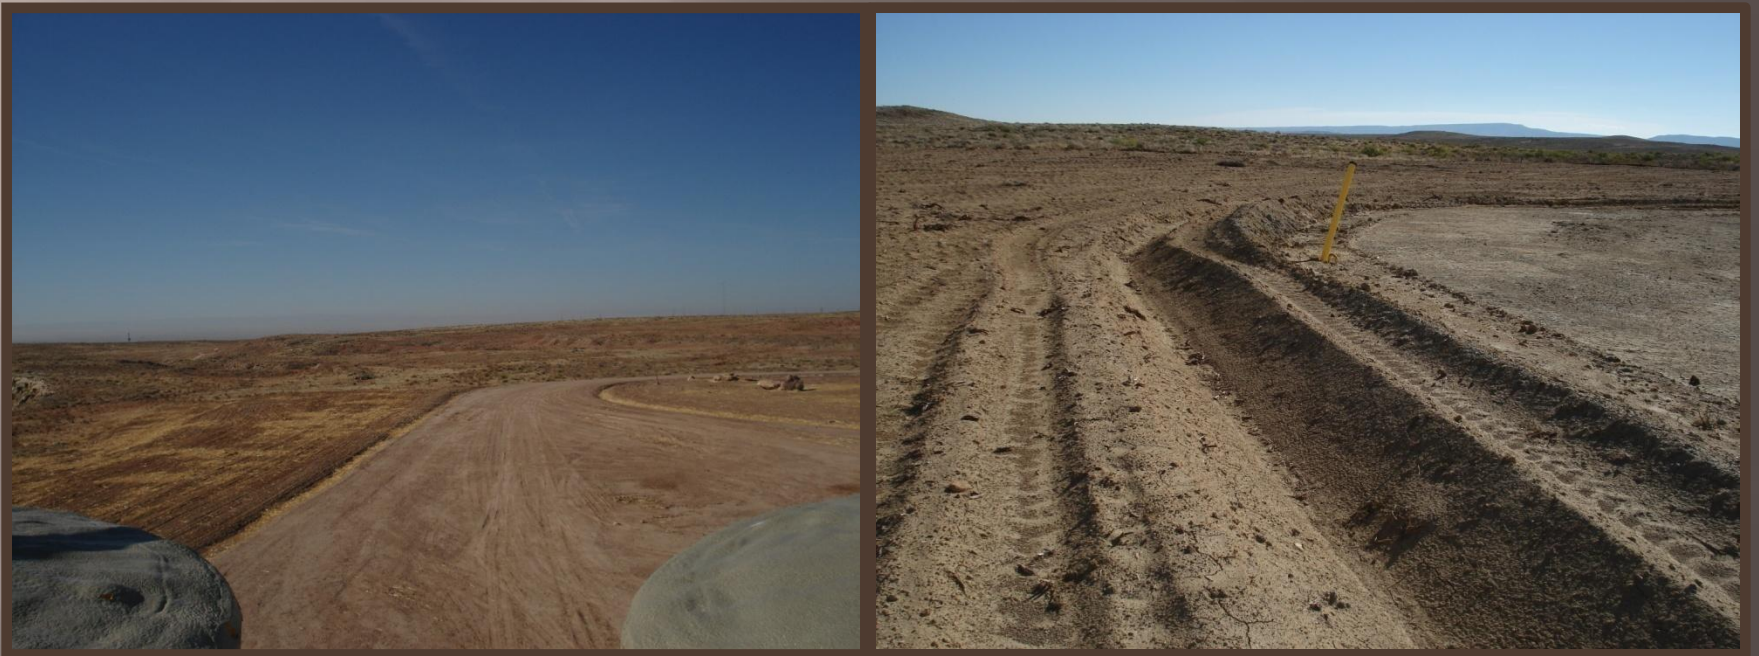
Ditch Perimeter of Production Pad

RW 34-27ADR , Red Wash Field, Uintah County, Utah

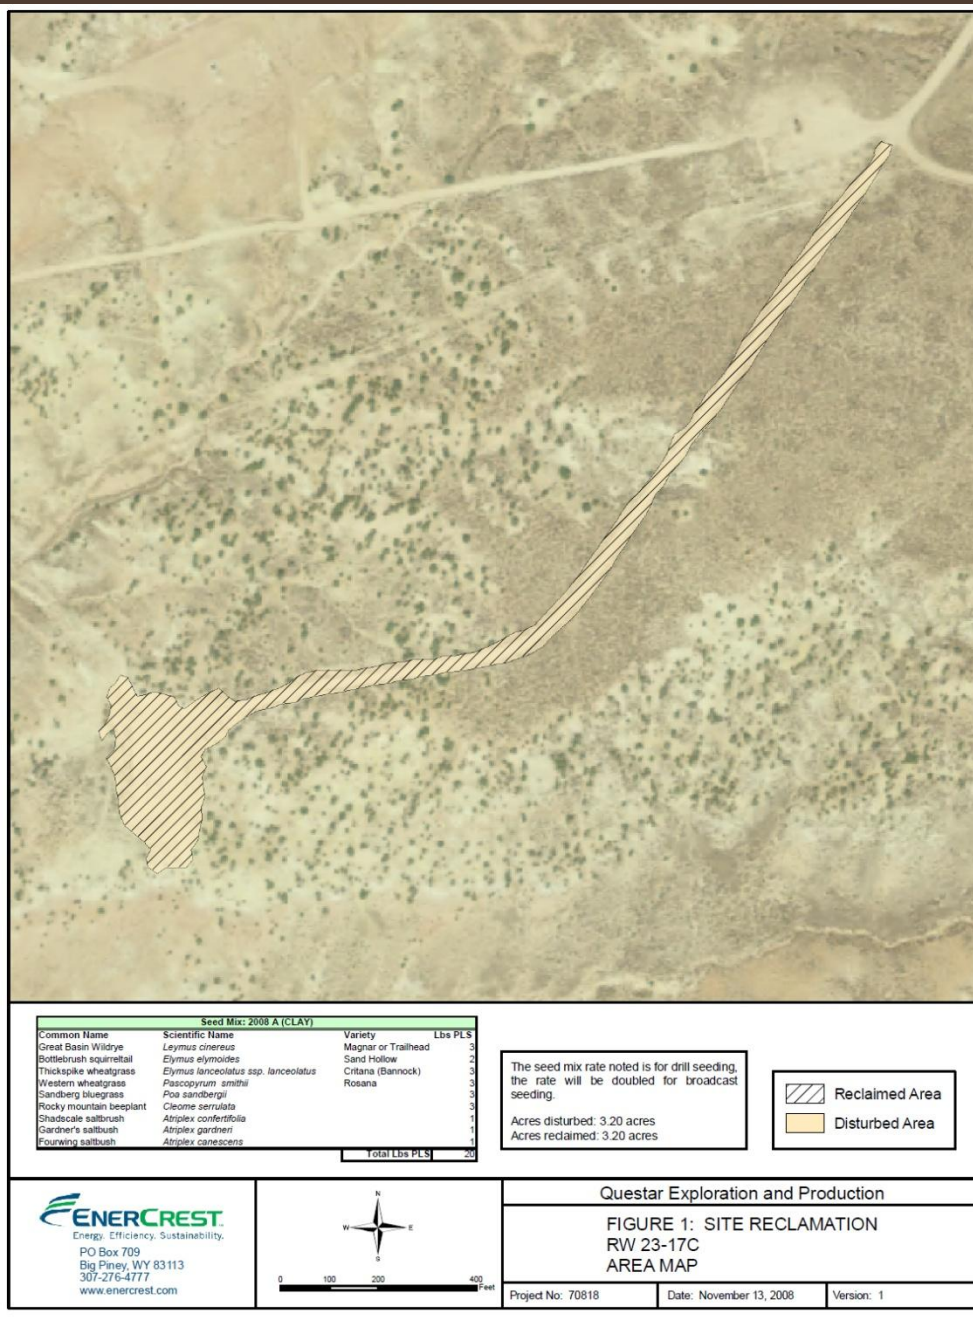
Long Term Tracking: Monitoring

- Monitor
 - Site Information
 - Vegetation Assessment
 - On Site and Off Site
 - Other Observations
 - Reclamation Assessment
 - Recommendations

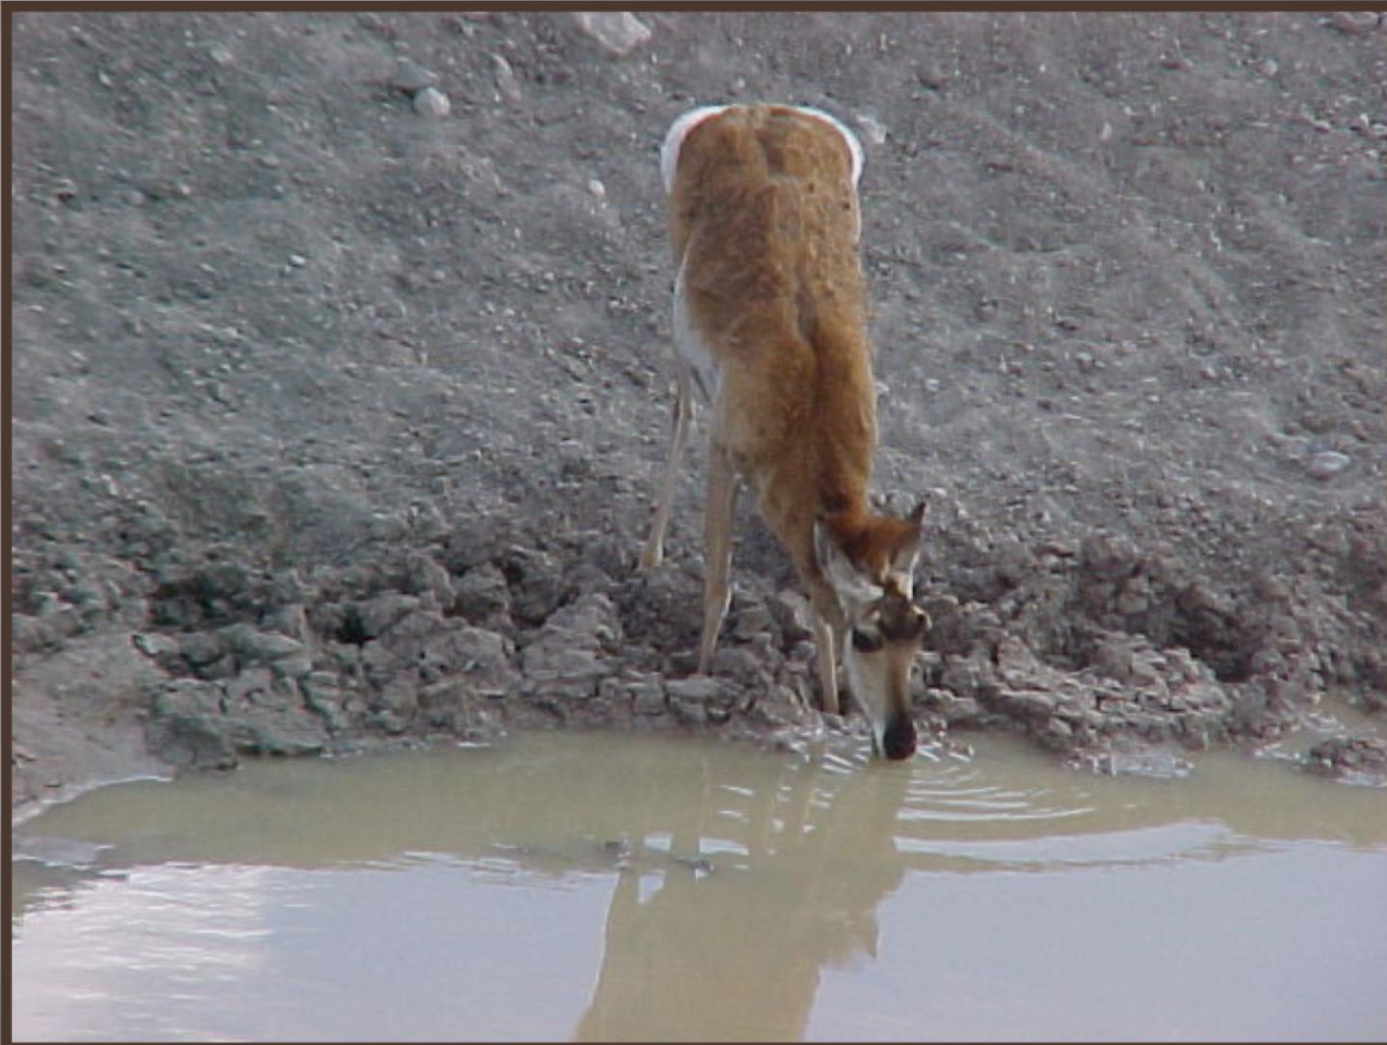
Ponds built while reclaiming locations.
